**KOP 4
 Highway 306**

Figure 3.9-5

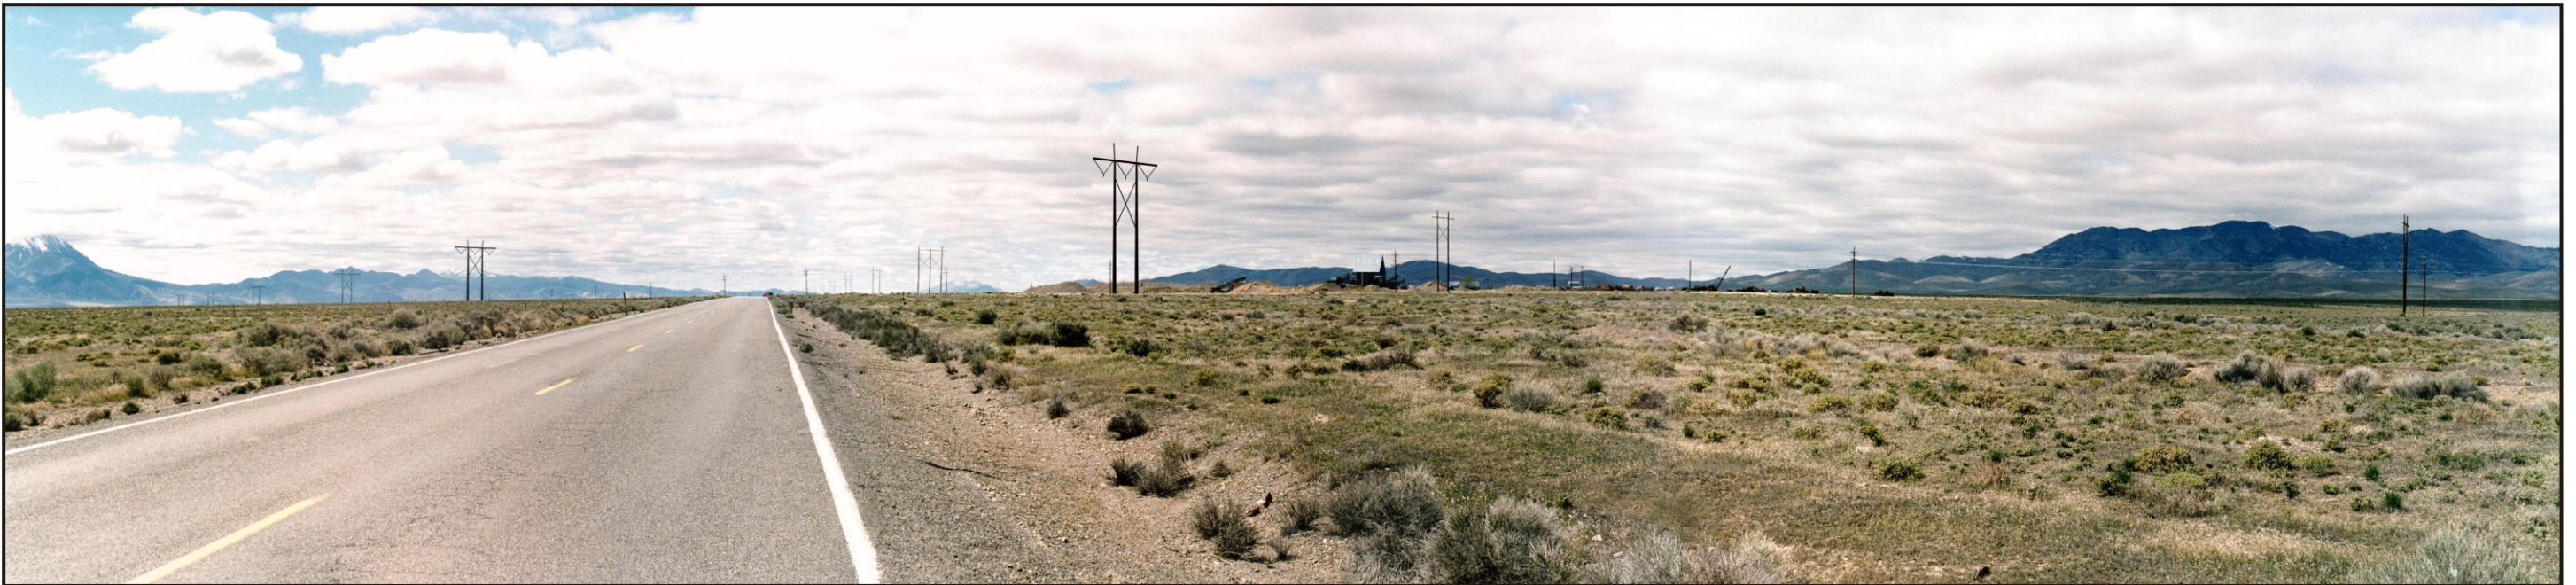
Future Conditions

Summary of Visual Changes

Type/Sensitivity of Users: Local highway travelers with moderate concern for scenic quality
 Volume of Users: Moderate
 T/L Distance from Viewer: From background to foreground crossing views
 T/L Prominence in Landscape: Moderate - seen primarily against distant landforms but briefly against the sky at the crossing
 Existing Modifications: Existing wood pole transmission and distribution lines, various types of buildings and substantial ground disturbance

Contrast Rating: Moderate
 VRM Class: IV
 Visual Impact Rating: Low
